On the Ground with Diesel Corrosion

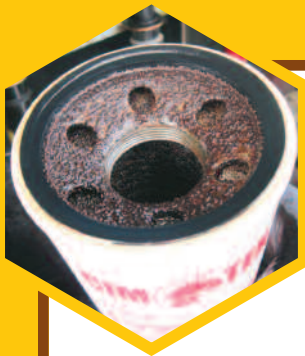
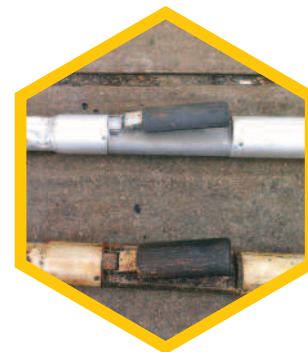
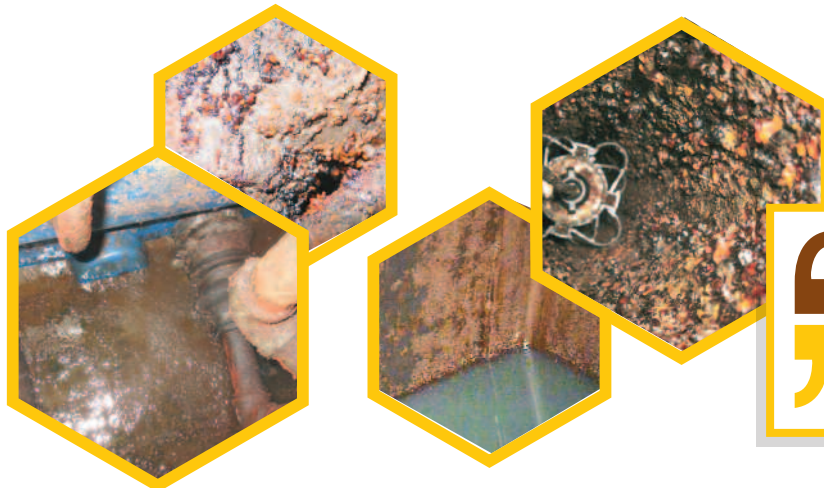
The images you see here are representative of the extreme conditions we discovered.

Unlike the mild orange-colored oxidation that would be typical for corrosion in this environment, we have seen large tubercles and nodules that can vary in color from yellow to orange to reddish brown and even black. The metal components in the vapor space of both steel and fiberglass tanks, including bungs, risers, caps, plugs, submersible turbine pump (STP) shafts, ball float assemblies and flapper valves have all exhibited this unusual form of aggressive corrosion.

It has not been uncommon to find a severely corroded ball float assembly or bungs completely covered in tubercles, some of which can be up to an inch long. On one occasion, the top of a riser pipe broke completely in half as a result of the corrosion.

We have pulled completely corroded STP shafts from tanks, and in some cases are not even able to remove them due to the excessive corrosion in the riser. Layers of corrosion and tubercles have built up so severely that the inside of the riser is no longer wide enough for the STP motor to be removed or serviced.

Perform regular visual inspection inside the ATG or other riser pipes accessible from grade, looking for any sign of potential corrosion.

Remove and inspect the ball float or flapper valve overflow prevention equipment—perhaps incorporated as part of a periodic inspection such as PEI RP900.

The single biggest thing you can do is manage water. Do everything possible to keep water from entering the tank:

One of EPA's recommendations is to perform an internal video inspection of your tank. Tanknology's TankCam® remote visual tank inspection service, for example, can be used for this purpose, as it was for the EPA study. Such an inspection provides you with a clear picture of what's happening inside your tank without having to empty it.
